# Invitation to Bid

**Project Location:** Pioneer Park  
1849 State Hwy 2  
Shenandoah, IA 51601

**Project Description:** Complete renovation of the pond at Pioneer Park. Project includes the following:

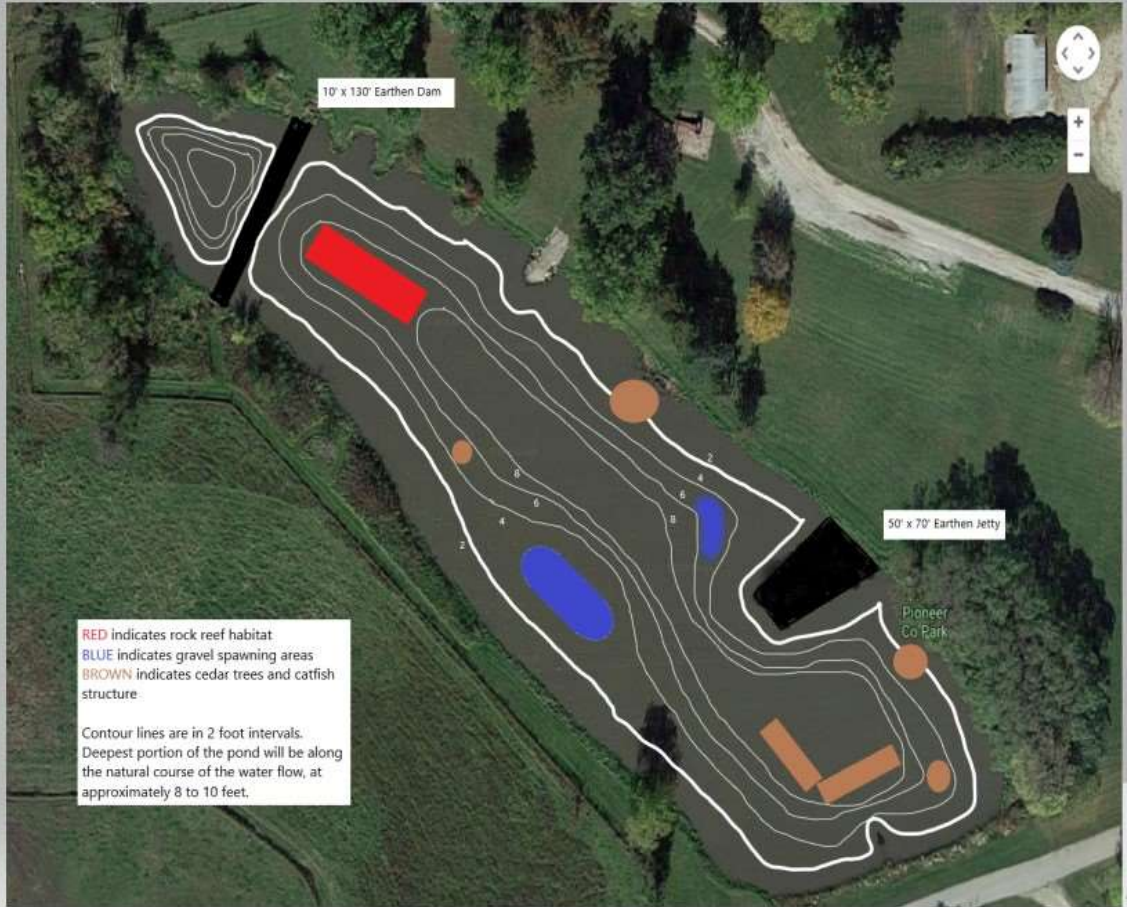
\*Currently, the pond has a mean depth of around 2 feet with the deepest portion being around 4 feet. As shown in the attached picture, we are looking at deepening the pond to be approximately 8-10 feet in the center and tapering up (see attached diagram).

- Breaching of current outflow pipe to be patched at end of renovation.
- Removal/dredging of approximately 750,000 cubic feet of sediment to deepen and reshape the pond.
- Construction of an earthen dam approximately 10' x 130' to create a sediment collection basin in the northern 0.25 acres of the pond. Outflow tube will need to be installed in this dam to allow surface water to flow from the basin to main pond. Both sides will need to be armored
- Construction of a 50' x 70' earthen fishing jetty, 3:1 slope, armored at least 2 feet above and below water level
- Construction of gravel spawning areas and a "rock reef" (see additional information).

\*Gravel spawning beds consist to small, round rock placed in a bed along the pond bottom (approximately 8-10 inches deep)

\*Rock Reef consists of a rectangular frame of large rock that will enclose an area covered in smaller rocks/gravel.
